Home Inspection Report

123 Anystreet
North Myrtle Beach, SC

Inspected On Wed, Jan 1, 2025 at 10:00 AM

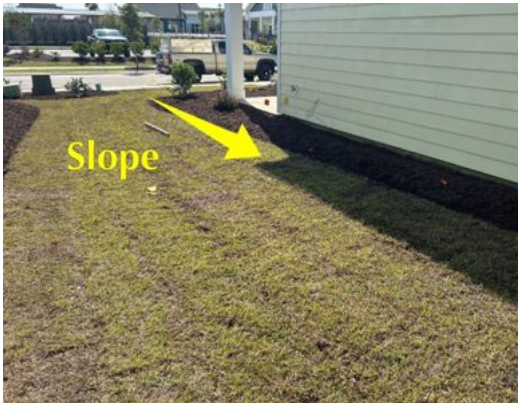
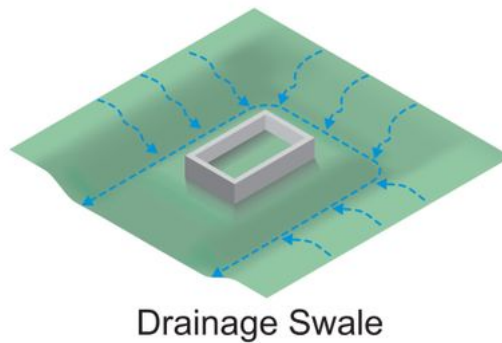
Comment 1

The grading around the house is level or slightly sloped towards the house. There was standing water next to the house. Standing water indicates a proper swale has not been installed. The concrete foundation can become damaged with long exposure to moisture.

Recommend grading be sloped away from the house at 6" for the first 10' to improve drainage away from the homes foundation. It is also recommended a swale be installed between properties.

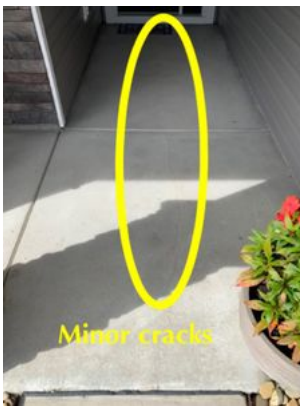
Comment 2

Minor cracks were observed on the concrete porch. Recommend monitoring over time for change in elevation and expansion.

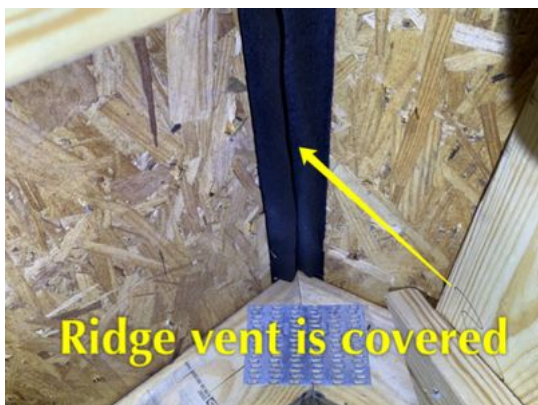
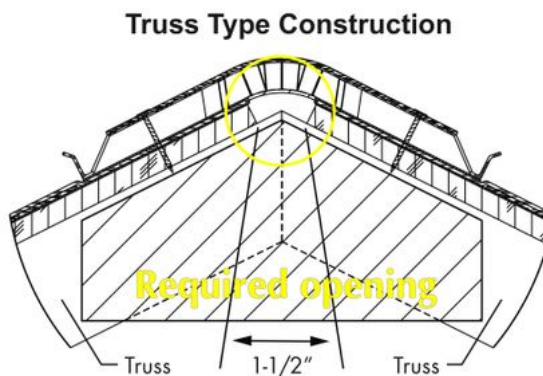
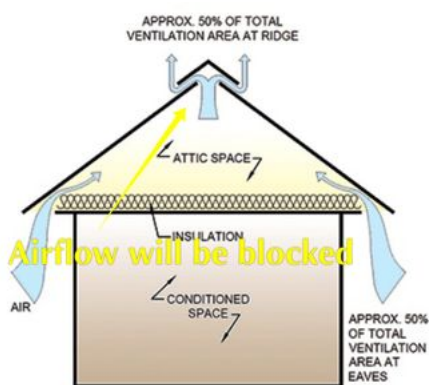
Comment 3 Deficiency

The roof ridge vent is covered with felt paper in the attic space. The felt paper it's blocking the natural flow of air movement from the exterior soffit vents to the ridge vents in the attic. The result is an attic space that is not properly ventilated and will get extremely hot. This excessive heat may result in shortening the lifespan of the roof sheathing material and shingles.

Recommend the felt paper be removed to properly ventilate the attic space.

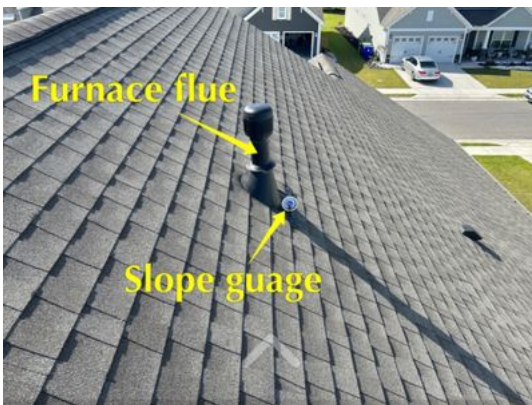
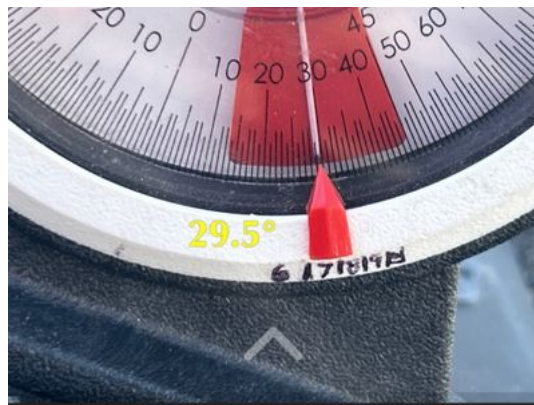
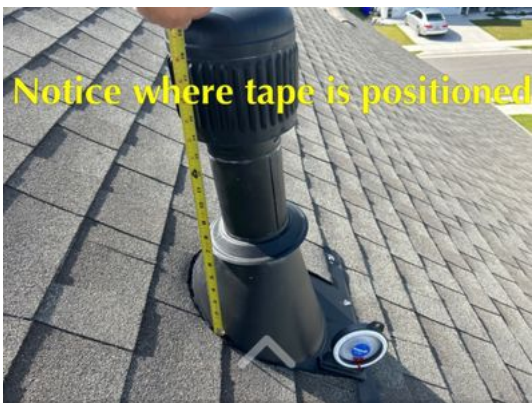
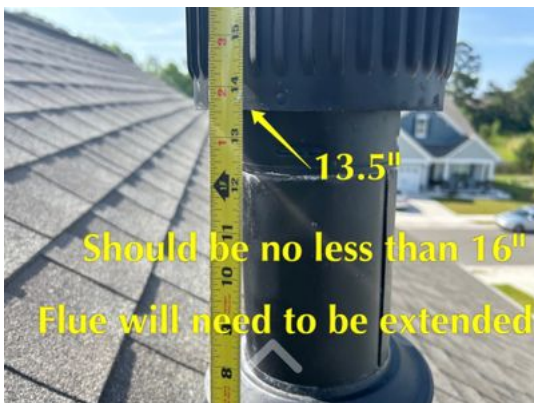
This roof is greater than a 7:12 pitch or 7/12 slope roof. The flue piping must maintain a minimum of 16" from the roof to the lowest discharge opening of the flue pipe. The current configuration only allows for 13.5". This will be considered a material defect.

It is recommended the flue pipe be raised to be compliant with the South Carolina fuel gas code 503.6.10.1 See figure 503.6.5 for reference. All repairs should be performed a licensed HVAC contractor.

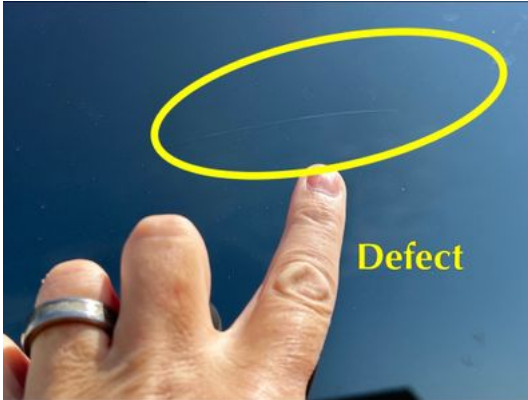
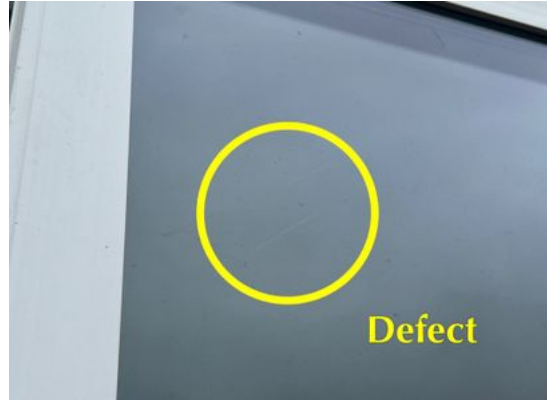
Comment 7

There are a number of windows installed in the house that have coating defects or scratched interior coating. This is not a defect that can be repaired. The window glass units will need to be replaced.

It is recommended the windows be replaced by a licensed contractor.

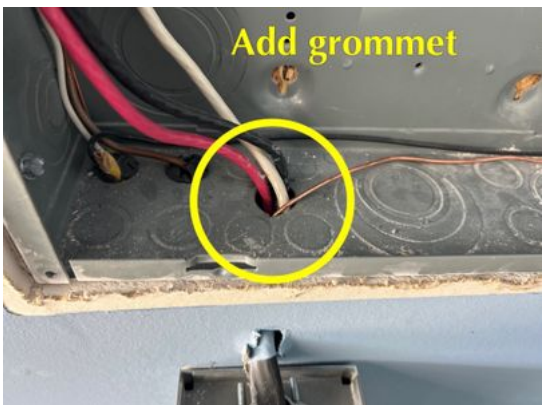
The electrical panel utilizes non metallic or NM cable. There is a missing grommet between the sharp metal cabinet and the non-metallic cable. The NM cable is not properly protected from the sharp electrical cabinet edge. This may create a cut in the cable and cause a fire. This will be considered a material defect.

See South Carolina Residential Code E3907.6. The code reads “Conductors entering cabinets and panel boards shall be protected from abrasion and shall comply with section E3906.1.1. It is recommended this penetration be made code compliant by a licensed electrical contractor.

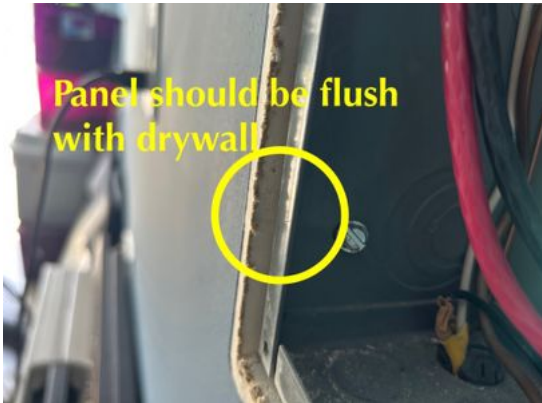
The electric service panel is mounted behind the finished surface of the garage sheet rock. It is recommended that the panel board be relocated flush with the finished sheet rock and the dead front cover properly installed. The dead front cover should be installed tight to the panel board to prevent electrical arcs from igniting surrounding combustible materials.

See South Carolina Residential Code E3907.3. This code reads “In walls constructed of wood or other combustible materials, cabinets shall be flush with the finished surface or shall project there from”. This panel board defect is considered a material defect.

Repairs should be performed by a licensed electrical contractor.

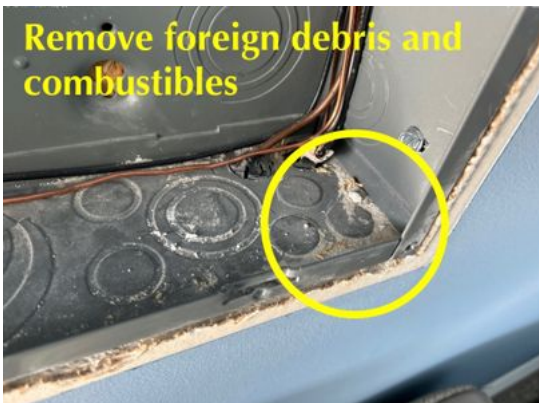
See South Carolina Residential Code E3404.7 code reads “Internal parts of electrical equipment, including busbars, wiring terminals, insulators and other surfaces shall not be damaged or contaminated by foreign materials such as paint, plaster, cleaners or abrasives, and corrosive residue. There shall not be any damage to parts that may adversely affect safe operation or mechanical strength of the equipment such as parts that are broken, bent, cut deteriorated by corrosion, chemical action, or overheating. Foreign debris shall be removed from equipment”.

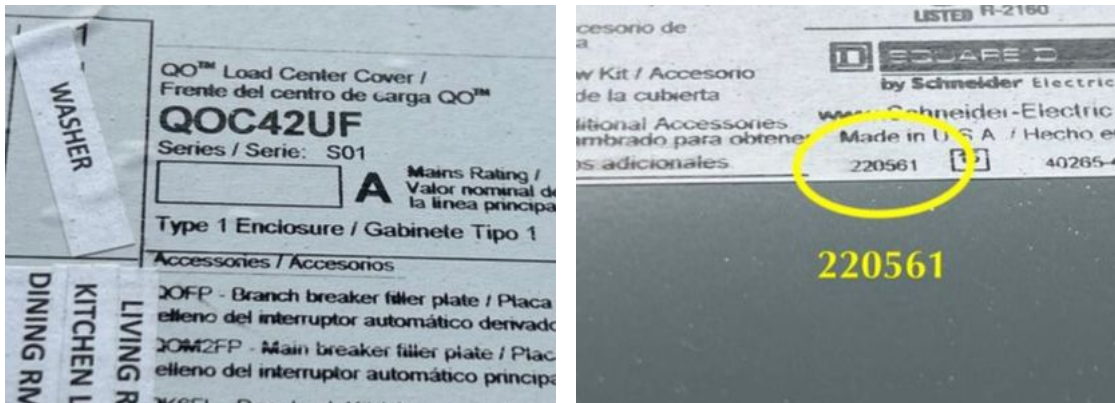
Comment 8

The electrical panel is a QO Square D model. This is a model that is known to have defects. Approximately 1.4 million panels in the US have been recalled due to panel fires. Any Square D panel covers that has a six digit date code between 194871-221343 must be evaluated by the manufacturer for evaluation and possible repair or replacement.

This is a recalled panel and will be considered a material defect. It is recommended the builder be contacted to notify the rest of the buyers in the neighborhood that they may have a defective panel installed too. It is this home inspectors experience that defective panels will be found throughout the neighborhood. It is also recommended the manufacturer of the service panel be contacted for evaluation and repair or replacement. Information from the manufacturer can be found at:

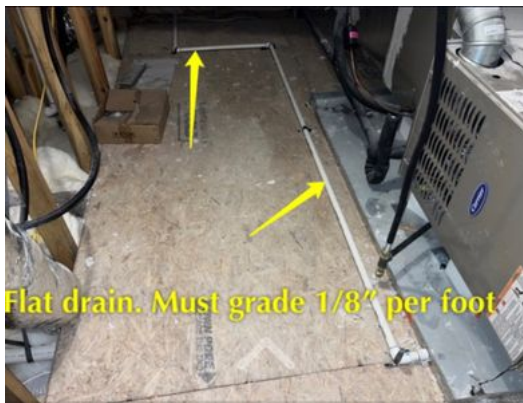
The auxiliary pan installed under the air handler unit in the attic has a improperly installed drain. The drain piping is ran flat for a number of feet. See South Carolina Residential Building Code M1411.3.1. The code requires that this drain shall slope to the exterior at 1/8" per foot grade.

It is recommended that the drain corrections shall be performed by a licensed HVAC contractor.

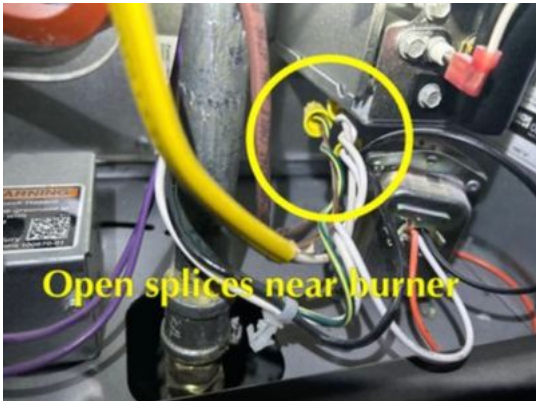
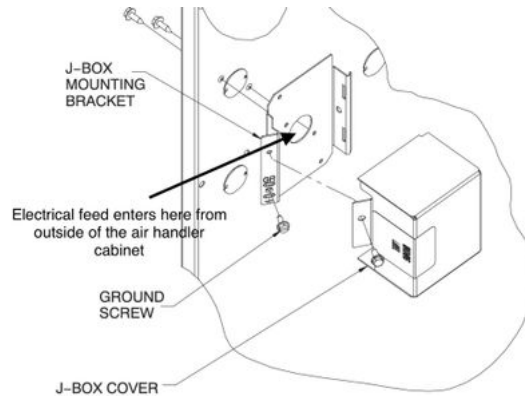
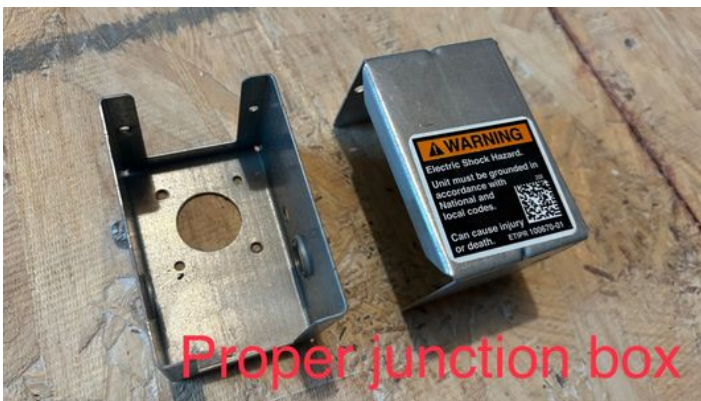
There are live open splices exposed in the air handlers. The furnace is a vibrating appliance and the junction box should be properly sealed to protect splices. When the electrical feed enters the furnace it should not cross any section of the furnace interior but go directly from a cabinet exterior penetration into the manufacturers supplied electrical J box. In the current configuration the electrical feed will have to be removed to perform annual maintenance or perform component replacement inside of the air handler. This creates an electrical hazard to the maintenance personnel servicing the air handler.

All repairs should be performed by a licensed electrical contractor.

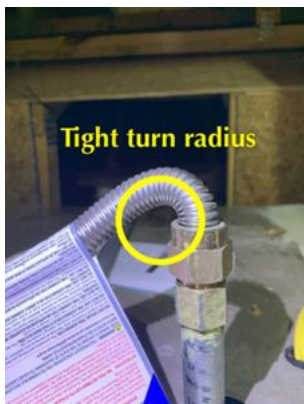
The appliance connector for the gas furnace has a very tight radius before entering the furnace. The manufacture of the flexible appliance connector recommends this radius match that of a golf ball or be 1 1/2". When this radius is made too tight the gas flow is interrupted.

Repair of the appliance connector should be performed by a licensed HVAC contractor.

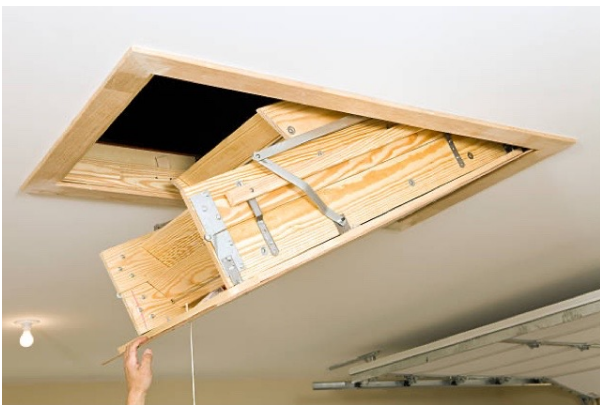
Comment 19 **Deficiency**

The attic door does not open or close properly. It took a large amount of force to open and close the door. Recommend the attic door entry stairs be adjusted for easy opening and closing operation.

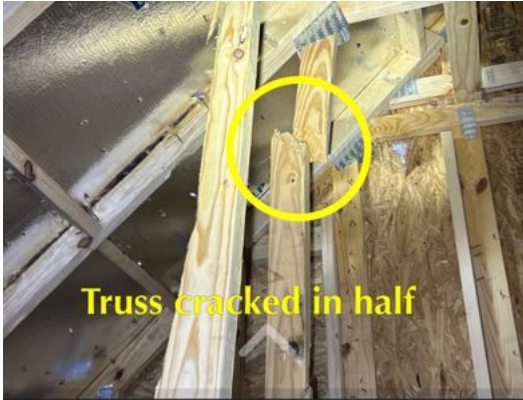
Comment 20

There is a truss in the attic that is broken. This truss will need to be inspected by a truss structural engineer. The structural engineer will need to draft a repair method. This repair method will be given to the builder in the form of a print.

It is recommended the truss be properly repaired by a licensed carpenter contractor according to the structural engineer drawing. It is recommended this document be installed somewhere near the attic entrance so that future homebuyers may reference. This defect will be considered a material defect

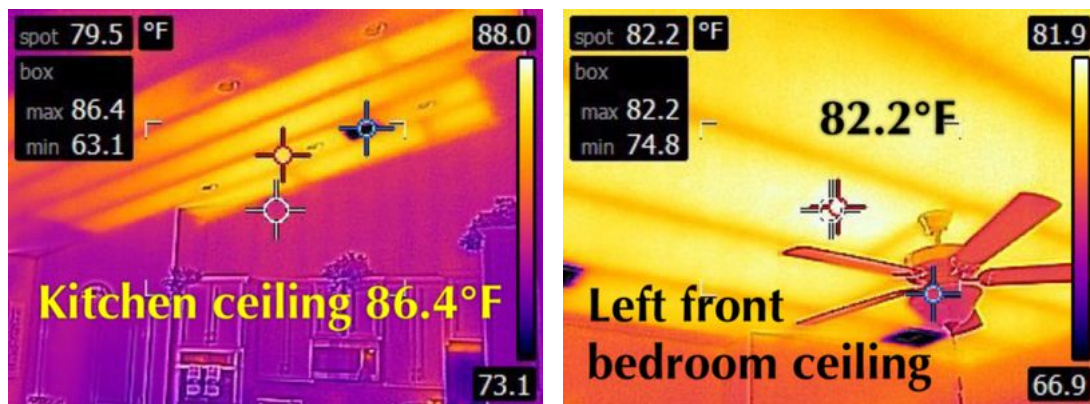
Comment 22

The house was surveyed for improperly insulated ceilings and walls using a thermal camera. A large section of the ceiling in the kitchen and left front bedroom may have improperly installed or missing insulation. These areas of the house were not accessible from the attic during the home inspection.

It is recommended that this area be inspected by a licensed insulation installer. It is recommended that all repairs to the attic insulation be performed by a licensed insulation contractor.

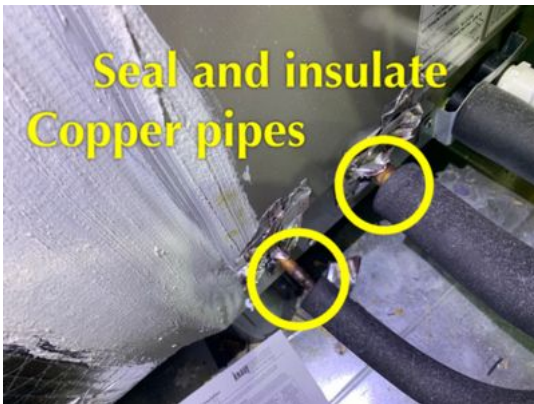
Comment 23

Conditioned air is leaking from the improperly sealed air handler penetrations. Condensation is forming on the improperly insulated line set material. Without sealing these penetrations properly the cold air leaving the air handler unit will create condensation in the summer and create premature corrosion of the air handler unit and the auxiliary pan below the air handler unit.

Recommend the air handler penetrations be properly sealed by a licensed HVAC contractor.

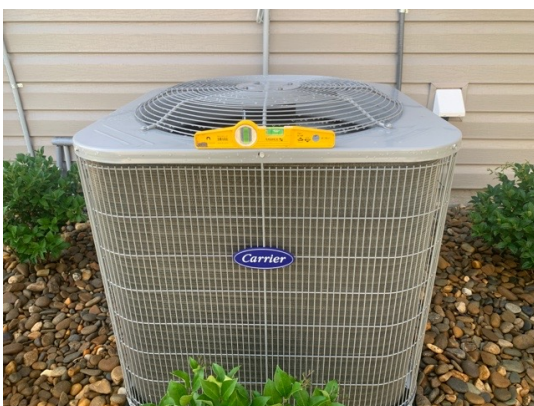
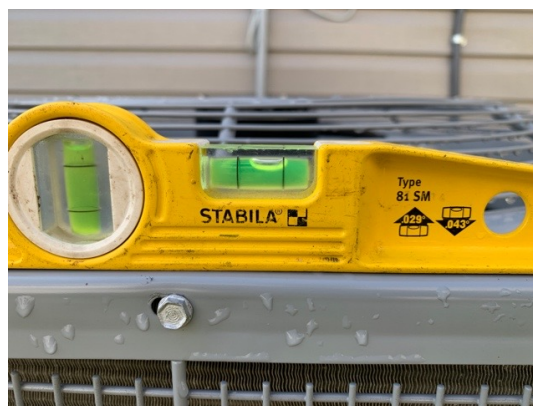
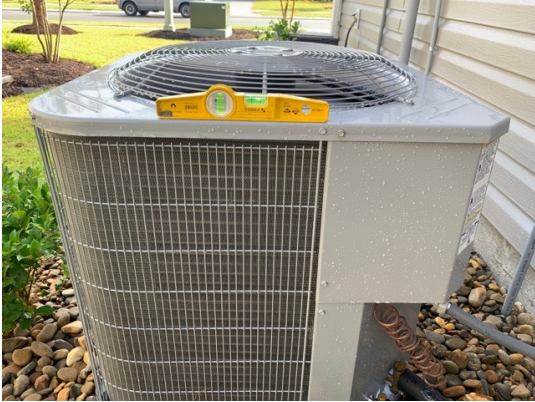
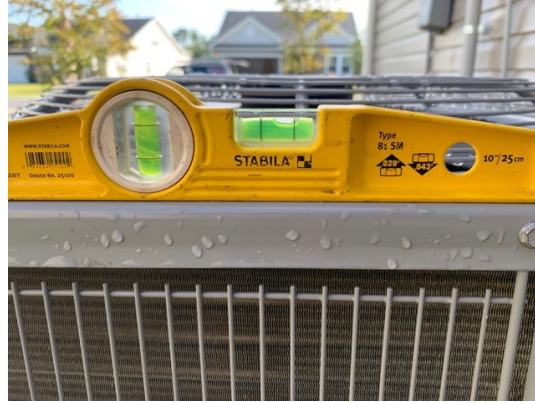
Comment 24

The air conditioning condensing unit isn't level, as a result the oil inside of the compressor will not be level either. This can lead to one side of the compressors motor not being properly lubricated. Ultimately that can cause compressor damage due to the grinding of the motors moving parts.

It is recommended that the condenser be properly leveled by a licensed HVAC contractor.

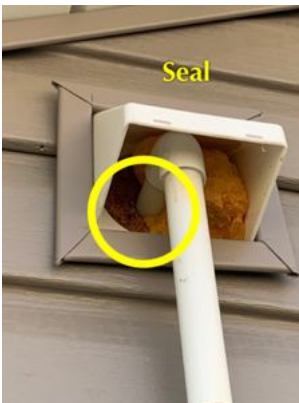
Comment 25

The air handler condensate drain to the exterior needs to be properly sealed to prevent air and moisture intrusion into the homes envelope. Sealing the penetration with approved material is recommended.

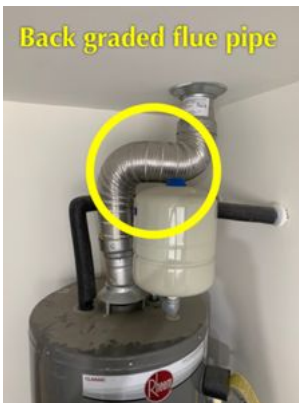
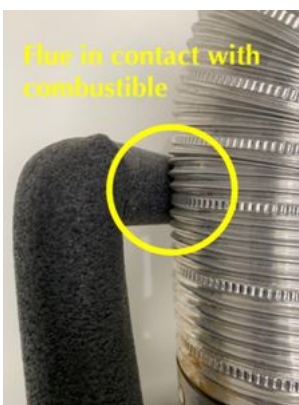
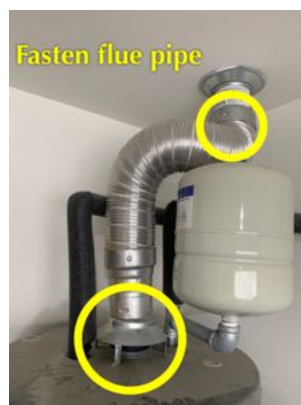
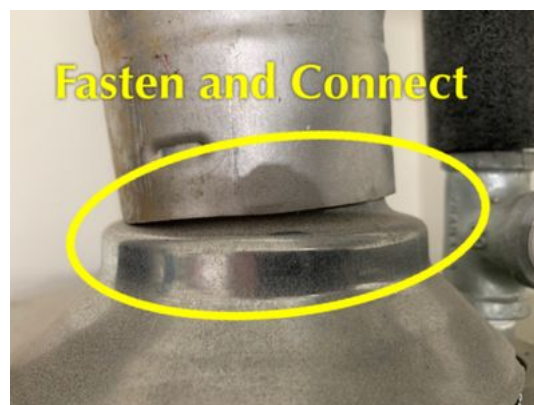
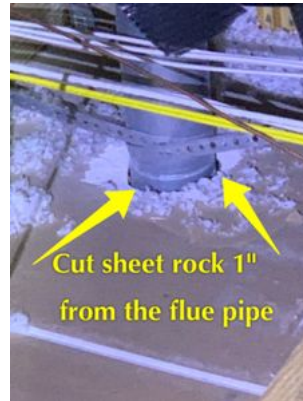
Comment 26

The water heater flue pipe (vent connector) is not properly connected to the water heater diffuser hood or the ceiling thimble. It is recommended the flue pipe material be secured to the draft hood with sheet metal screws. It is also recommended the diffuser hood be secured to the water heater with sheet metal screws. The flue piping material should also be secured to the ceiling thimble with sheet metal screws.

See South Carolina Residential code G2427.10.7. Back graded flue piping may result in back draft of flue gases and introduce carbon monoxide into the garage. It is recommended that the flue rise to the ceiling thimble at 1/4 inch per foot.

All repairs should be performed by a licensed plumbing contractor.

Repair by a licensed plumbing contractor is recommended.

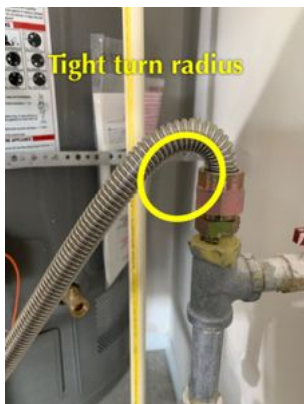
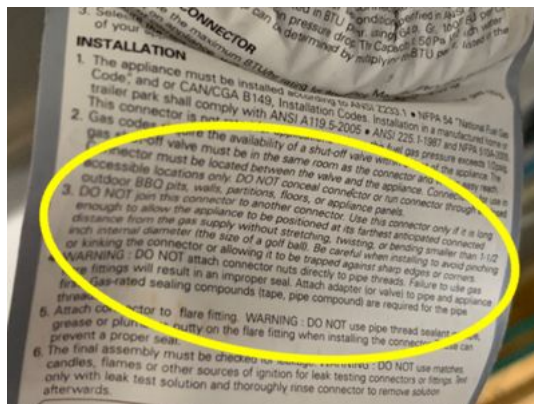
Comment 28 Deficiency

The gas flex (appliance connector) to the water heater is extremely tight. The manufacturers installation instructions requires the bend radius not be smaller than 1-1/2" or the size of a golf ball. Right angles are not recommended. Recommend the addition of a longer nipple to relax the appliance connector or the installation of a longer appliance gas connector.

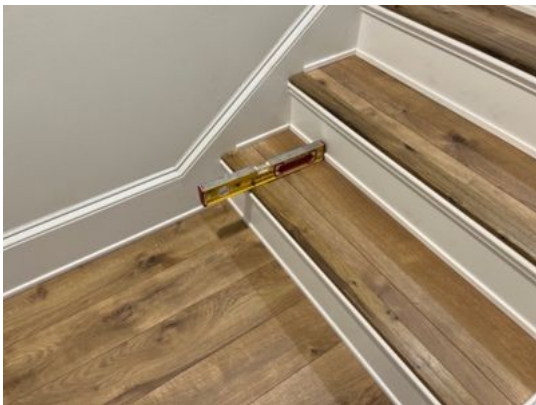
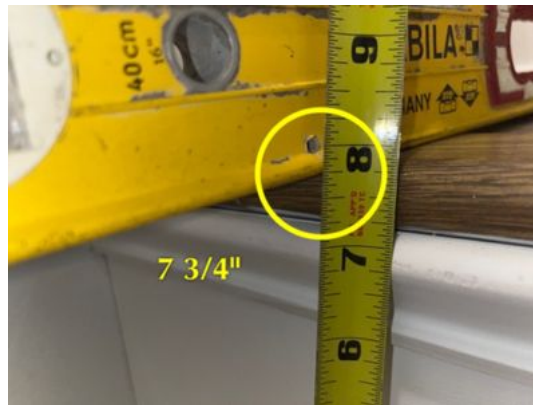
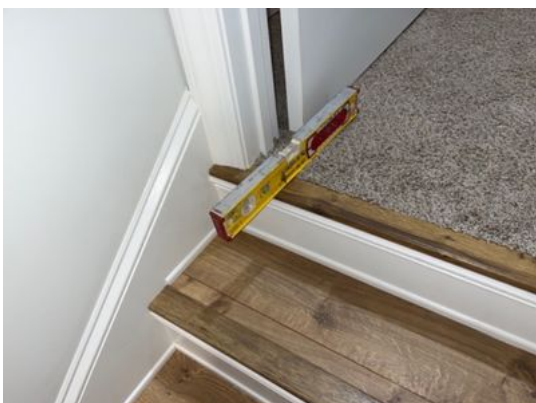
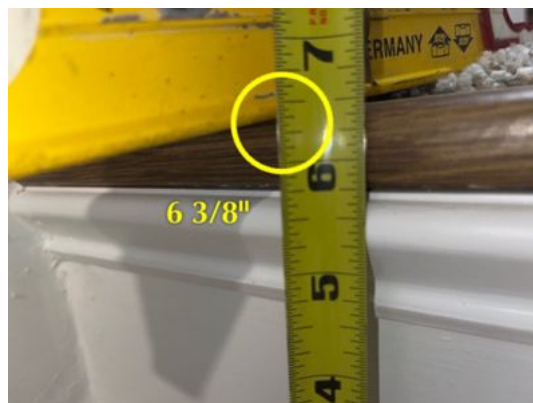
The interior stair steps have riser heights that vary by 1-3/8". The greatest riser height within any flight of stairs should not exceed 3/8" between the tallest and shortest riser. This defect presents a tripping hazard and will be considered a material defect.

Repair of the stairs is recommended and should be performed by a licensed carpenter contractor.

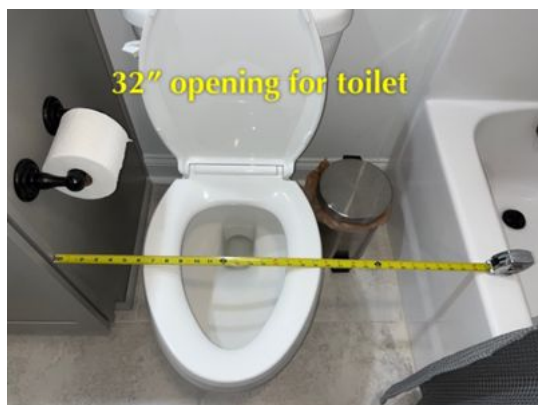
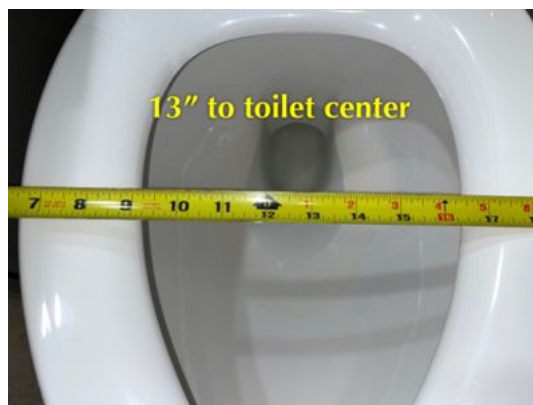
South Carolina Residential Code P2705.1(5) reads “A water closet, urinal, lavatory or bidet shall not be set closer than 15” from its center to any sidewall, partition, vanity or other obstruction.” It is recommended the installation of this lavatory be made code compliant by a licensed plumbing contractor.

Once the repairs are made it is recommended the repairs be tested and inspected per South Carolina Residential Code P2503.1. The code reads “New plumbing work and parts of existing systems affected by new work or alterations shall be inspected by the building official to ensure compliance with the requirements of this code.”

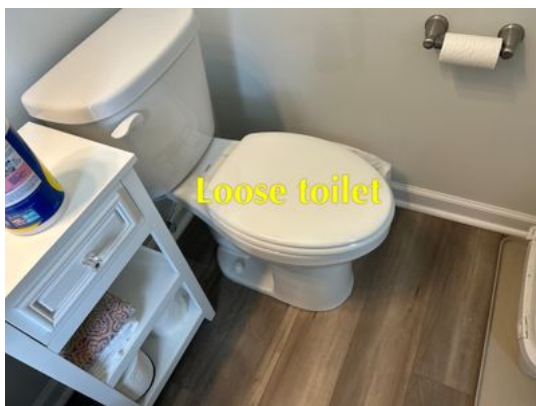
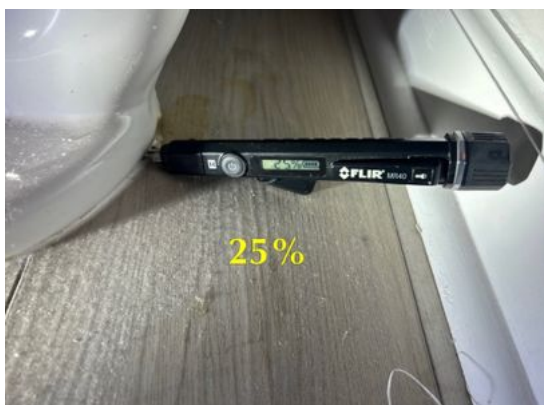
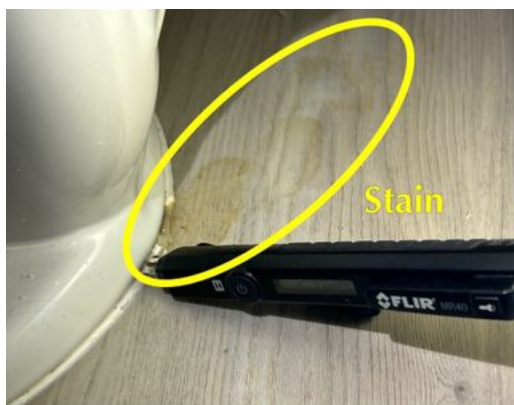
Comment 33 Deficiency

It is recommended the toilet flange be verified It is properly secured to the floor. This is a floor outlet or floor mounted fixture. See South Carolina Residential Code P2705.1. The code reads “Floor outlet or floor mounted fixtures shall be secured to the drainage connection and to the floor, where so designed, by screws, bolts, washers, nuts, and similar fasteners of copper, copper alloy, or other corrosion resistant material.”

The toilet is loose in the right rear bathroom. The toilet is also leaking onto the floor.

It is recommended the toilet be pulled and inspected for the source of the leak.

It is recommended the toilet flange be properly secured to the floor and the toilet be properly secured to the toilet flange. All repairs should be performed by a licensed plumbing contractor.
