Home Inspection Report

123 Anystreet
North Myrtle Beach, SC

Inspected On Wed, Jan 1, 2025 at 10:00 AM

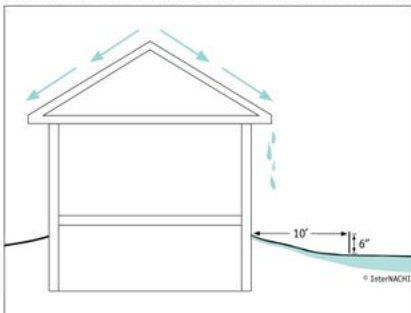
Comment 1

The grading around the house is level or slightly sloped towards the house. There was standing water next to the house. Standing water indicates a proper swale has not been installed. The concrete foundation can become damaged with long exposure to moisture.

Minimum-Grade Slope

Grade shall fall a minimum of 6 inches within the first 10 feet from the foundation walls.

Recommend grading be sloped away from the house at 6" for the first 10' to improve drainage away from the homes foundation. It is also recommended a swale be installed between properties.

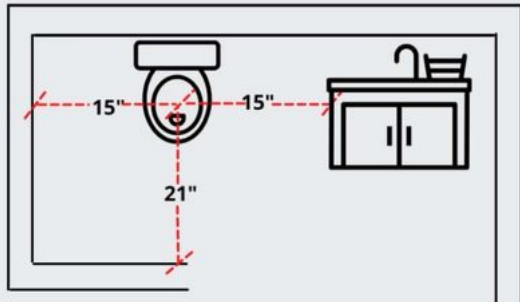
side & front clearances.

405.3.1 Water Closets, Urinals, Lavatories and Bidets

A water closet, urinal, lavatory or bidet shall not be set closer than 15 inches (381 mm) from its center to any side wall, partition, vanity or other obstruction. Where partitions or other obstructions do not separate adjacent fixtures, fixtures shall not be set closer than 30 inches (762 mm) center to center between adjacent fixtures. There shall be not less than a 21-inch (533 mm) clearance in front of a water closet, urinal, lavatory or bidet to any wall, fixture or door. Water closet compartments shall be not less than 30 inches (762 mm) in width and not less than 60 inches (1524 mm) in depth for floor-mounted water closets and not less than 30 inches (762 mm) in width and 56 inches (1422 mm) in depth for wall-hung water closets.
